William A. Bugge Bridge

(Hood Canal Bridge - 104/5.2)

Replacement Plan

East-Half Floating Portion

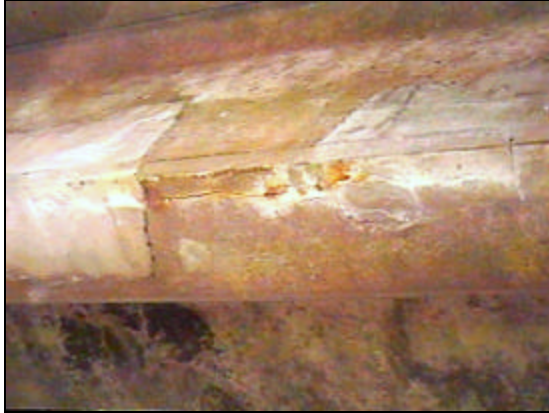
Previously repaired beam spalling.

Deterioration and relative ineffectiveness of rehabilitation contract work to preserve the original structural capacity.

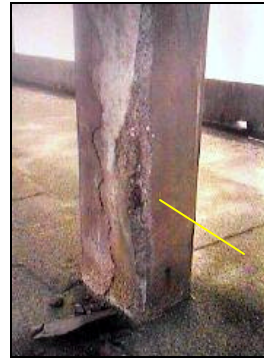
1984 repaired column, spalling in 1997.

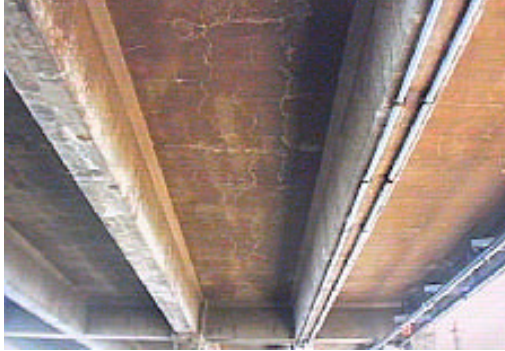
Bottom side of roadway deck

The roadway deck is 6 inches thick with 1 inch of concrete cover over both the top and bottom mats of reinforcing steel. In the pontoon portions the roadway deck is integral with and supported by concrete T-beams. The roadway deck sections on pontoons M, MM, P, S, T, and the east and west approach spans were constructed with light weight concrete (See Appendix A for pontoon location). The sections built with lightweight concrete represent nearly 50% of the east-half bridge length.

Bridge deck replacement is recommended on the east and west steel beam approach spans when the east half floating portions of the William A. Bugge bridge is replaced. The existing deck on the approach spans have a high level of chloride contamination with 56% of samples tested exceeding threshold for active corrosion of the reinforcing steel. The deck replacement construction could take advantage of the closure time required to replace the floating parts of the bridge. The cost of the deck replacement on the approach spans is estimated to be \$3.0 million.

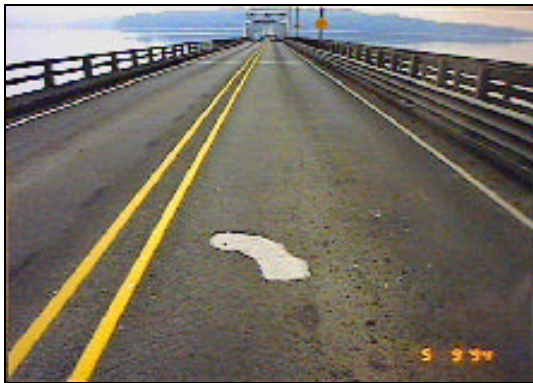
A 1/4” epoxy polymer overlay was applied to the roadway deck following the deck repairs. The polymer overlay is currently in good condition except for a few areas in the approach spans where the deck patching is beginning to fail and requires repatching by maintenance forces. The roadway surface is beginning to wear smooth, resulting in less traction when wet.

Polymer Overlay on the approach span.

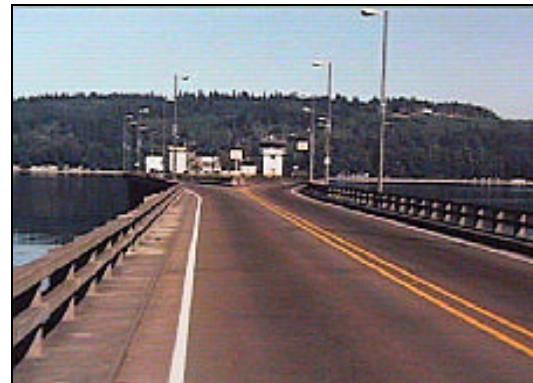
Polymer Overlay near the draw span.

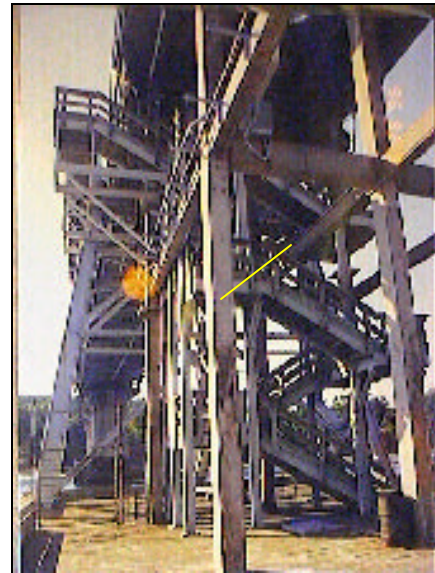
The original plans show columns on pontoons MM, M and P were constructed using lightweight concrete. Lightweight concrete has been specified for use in bridge decks before, but this is the only known WSDOT bridge columns constructed of lightweight concrete. Lightweight concrete has not performed well in the past.

Columns near the transition span

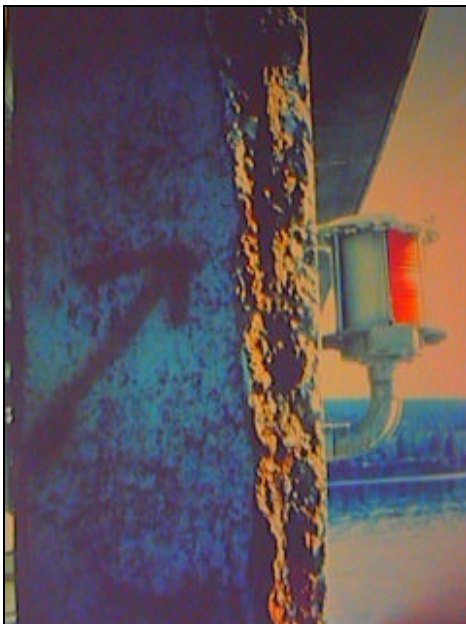
↑ **Column repair during 1984 repair contract.**

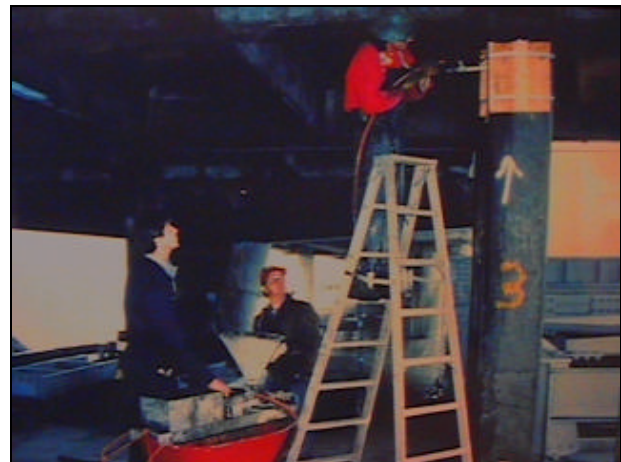
← **Column prior to 1984 repair.**

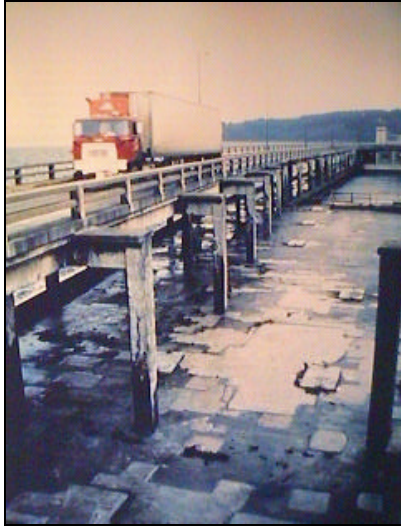
Pontoon patching prior to 1984

The pontoon decks have experienced significant corrosion induced delaminations and spalling dating back to the 1970^s. The chloride contamination in the pontoon decks has been measured at 8 pounds per cubic yard and is conducive to active corrosion. All pontoon decks were repaired in 1983-84. The cost of future pontoon deck repairs is estimated at \$500,000 at six year intervals over the next 20 years.

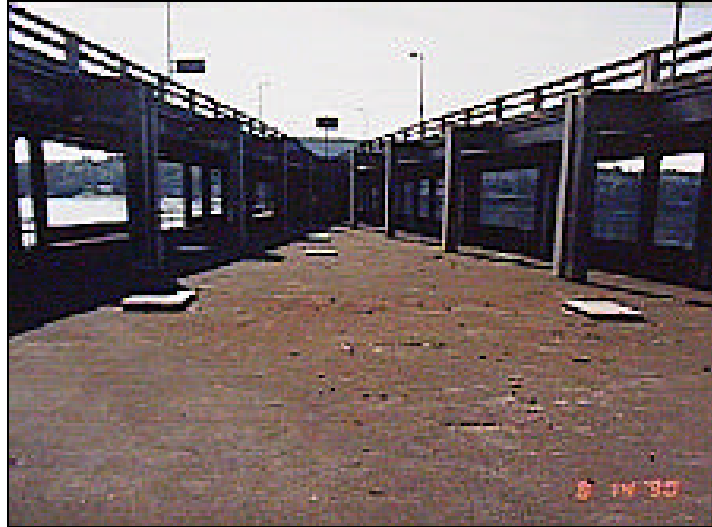
Polymer overlay over the pontoon top slab

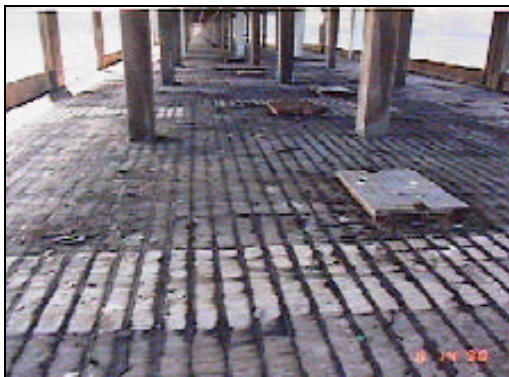
Cathodic protection on pontoon.

An extensive maintenance effort is required to check the corrosive forces attacking the reinforcing steel. The cathodic protection system was one of several experimental projects tried on this bridge to control deterioration. None proved to be very successful and have since been abandoned. Presently, maintenance and repair requirements exceed the region bridge maintenance crew's resources.

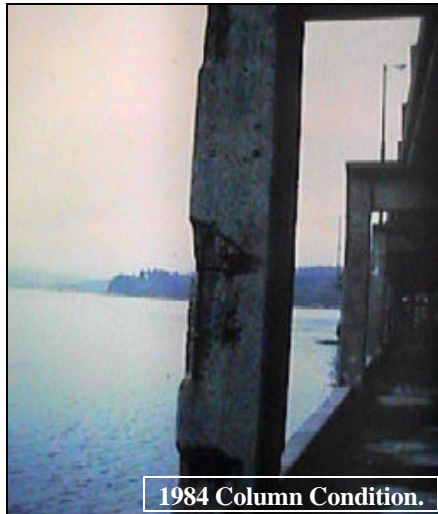
Spalled and deteriorated reinforced concrete columns were repaired during the 1984 rehabilitation. The Region reported the repairs included replacement of deteriorated concrete and heavily corroded reinforcing steel (Including column ties and main reinforcing steel bars).

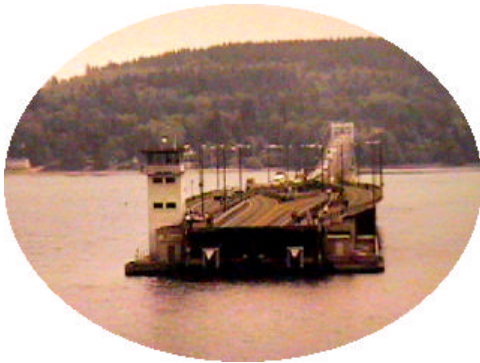
In mid-1995, the east-half drawspan began to seize, or become stuck, at the design opening of 300 feet. By mid 1996, the drawspan would stick if opened to more than 220 feet. Limit switches were set for a maximum opening of 200 foot on the east-half.

The opening problem is the result of high loads on the vertical guide-rollers causing excessive wear on the roller tracks, rollers, and equalizer frames. Misalignments caused by changes in pontoon configuration due to long-term creep, shrinkage, and unbalanced loadings are also contributing to the problem.

The current strategy is to continue to systematically eliminate binding points until the maximum 300 foot east-half opening is achieved. A long-term fix would require removal of the draw pontoon and replacement of all major mechanical components at an estimated cost of \$15-20 million and would involve two or more weeks of closure to vehicular traffic.
